Electrical Inspection
using Infrared
Thermography

SAMPLE REPORT - INDUSTRIAL PLANT

January 18,19,20, 2012

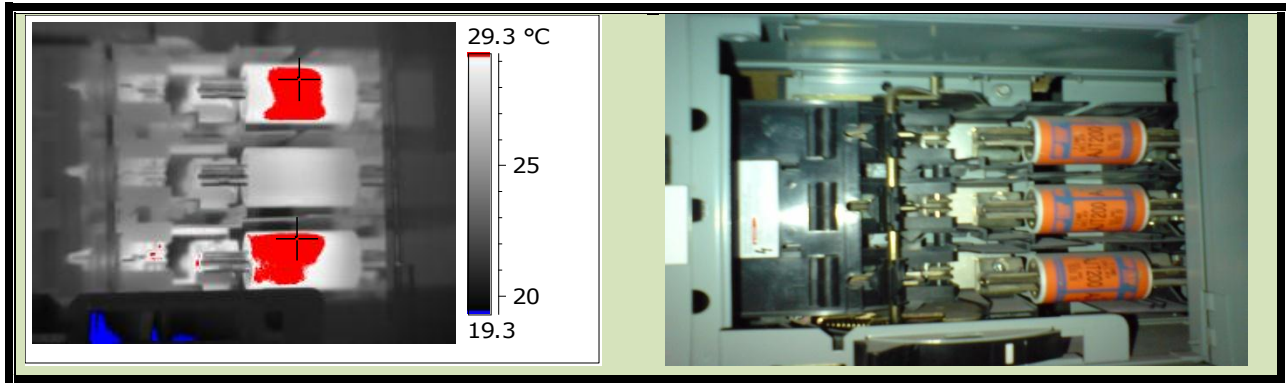
FAULT #1

PRIORITY	LOCATION	EQUIPMENT
Medium	Main Substation #1	200 amp Fused Disconnect Switch

PARAMETERS		ANALYSIS AND RECOMMENDATION
Date	1/19/2012	<p>Designation: "Lighting Panel" Brand: "Siemens" 200 amp 600 VAC 3 Phase 60 Hz</p> <p>CAT# VK73644</p> <p>Service Fused Disconnect Switches</p> <p>Replace A phase and C phase fuses. Exercise and lubricate switch mechanism.</p> <p>LOADS: A PHASE 63.1 amp B PHASE 60.9 amp C PHASE 64.8 amp</p>
Filename	IR_14944.jpg	
Max Temperature	30.5 °C	
Min Temperature	18.5 °C	
Atmospheric Temperature	21.6 °C	
Object Distance	2.2 m	
Sp1 Temperature	30.1 °C	
Sp2 Temperature	30.4 °C

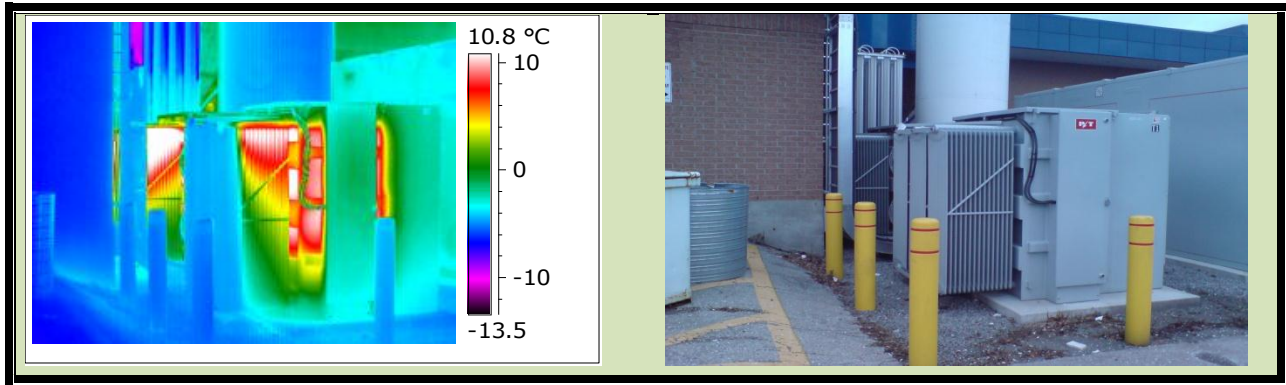
REFERENCE #1

PRIORITY	LOCATION	EQUIPMENT
None	Outdoor Substation	2500 KV Oil Filled Transformers

PARAMETERS		ANALYSIS AND RECOMMENDATION
Date	1/19/2012	S & C 2500 KV Typical thermal signature across transformer radiators.
Filename	IR_14936.jpg	
Max Temperature	16.3 °C	
Min Temperature	-11.5 °C	
Atmospheric Temperature	-1.6 °C	
Object Distance	11.0 m

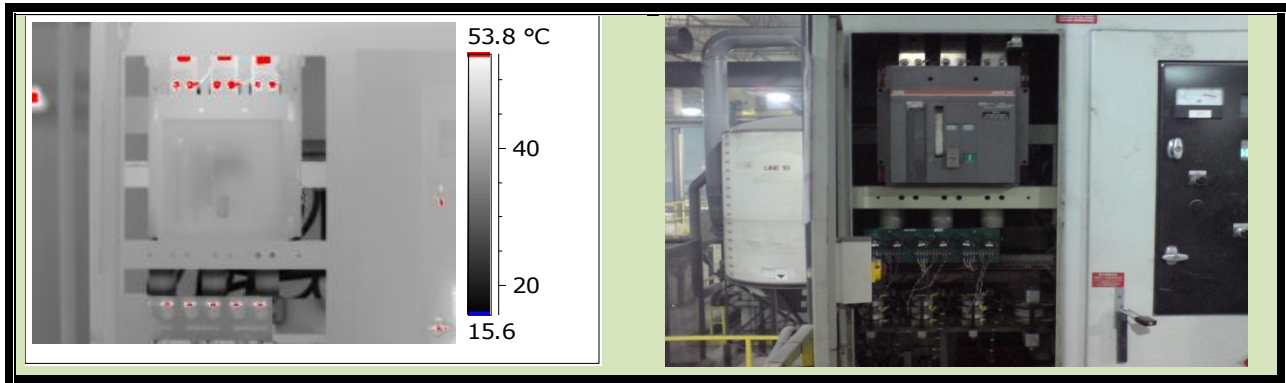
REFERENCE #2

PRIORITY	LOCATION	EQUIPMENT
None	Induction Furnace #5	2000 amp Molded Case Breaker

PARAMETERS		ANALYSIS AND RECOMMENDATION
Date	1/19/2012	Designation: Induction Furnace #5 "ABB" 2000 amp Molded Case Breaker 600 VAC 3 Phase 60 Hz No thermal variances due to high resistance. No loads taken.
Filename	IR_14938.jpg	
Max Temperature	91.3 °C	
Min Temperature	16.4 °C	
Atmospheric Temperature	28.0 °C	
Object Distance	1.8 m

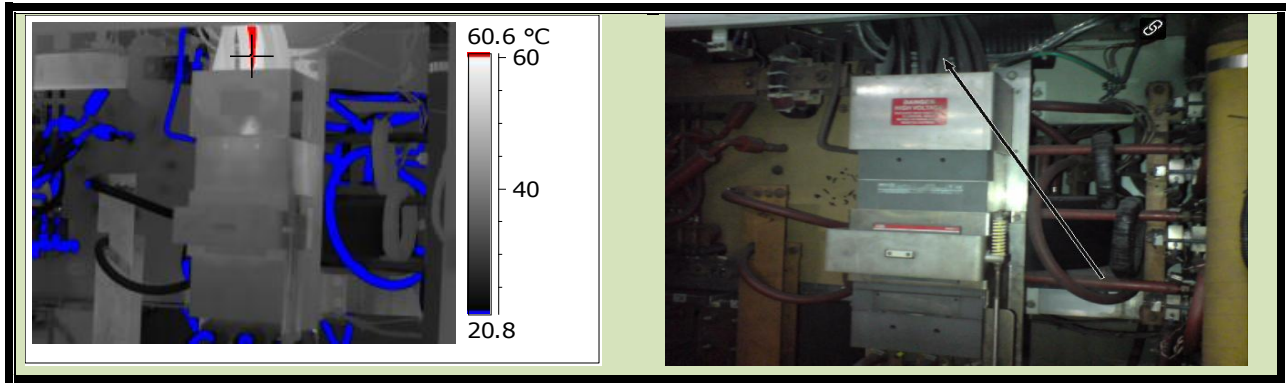
FAULT #2

PRIORITY	LOCATION	EQUIPMENT
High	Induction Furnace #10	1200 amp Molded Case Breaker

PARAMETERS		ANALYSIS AND RECOMMENDATION
Date	1/19/2012	Designation: "Induction Furnace #10" "ABB" 1200 amp Molded Case Breaker 600 VAC 3 Phase 60 Hz No loads taken. Thermal variance detected B phase lineside conductor, possibly migrating down to lug connection. Repair ASAP then re-scan.
Filename	IR_14940.jpg	
Max Temperature	65.7 °C	
Min Temperature	17.3 °C	
Atmospheric Temperature	28.0 °C	
Object Distance	1.8 m	
Sp1 Temperature	61.9 °C

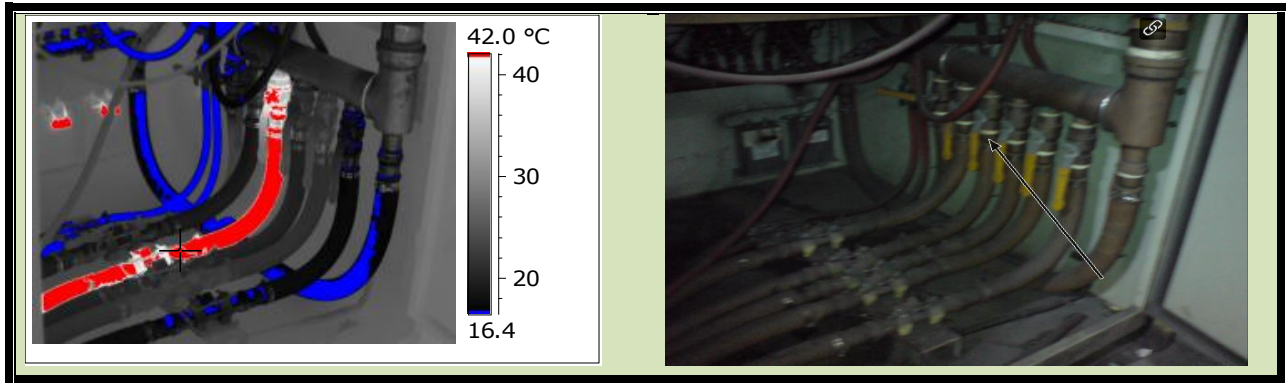
FAULT #3

PRIORITY	LOCATION	EQUIPMENT
Medium	Induction Furnace #20	1200 amp Molded Case Breaker

PARAMETERS		ANALYSIS AND RECOMMENDATION
Date	1/19/2012	<p>Designation: "Water Lines"</p> <p>Thermal variance detected across line #5 caused by possible congestion within line down-stream or up-stream. Repair ASAP.</p>
Filename	IR_14942.jpg	
Max Temperature	>150.2 °C	
Min Temperature	14.9 °C	
Atmospheric Temperature	28.0 °C	
Object Distance	1.8 m	
Sp1 Temperature	47.4 °C

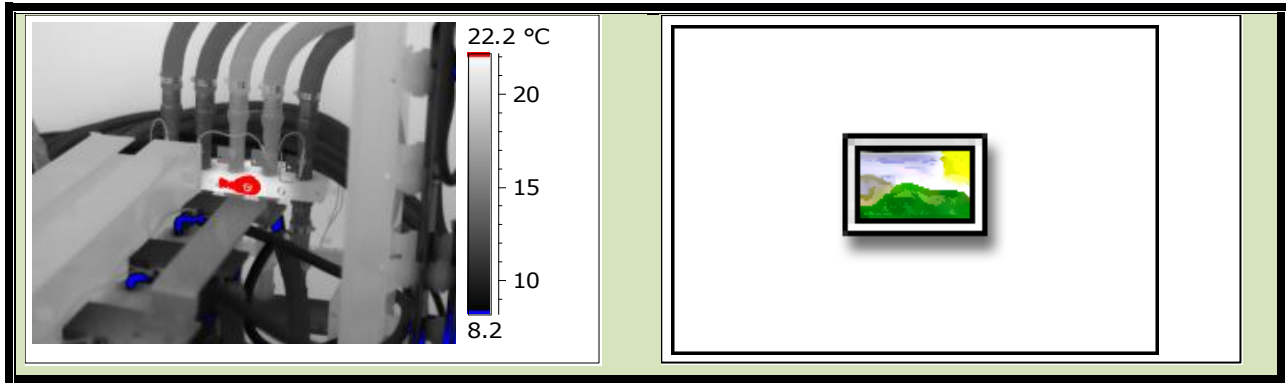
NOTE #1

PRIORITY	LOCATION	EQUIPMENT
	Induction furnace #5	Fibreglass Support

PARAMETERS		ANALYSIS AND RECOMMENDATION
Date	1/20/2012	Bracket (cold water) Signs of conduction. Investigate in greater detail.
Filename	IR_14956.jpg	
Max Temperature	23.5 °C	
Min Temperature	7.5 °C	
Atmospheric Temperature	20.4 °C	
Object Distance	1.5 m
